SUBJECT: FINAL PHASE III REMOVAL ASSESSMENT TRIP REPORT -

## FINAL PHASE III REMOVAL ASSESSMENT TRIP REPORT

## CANADIAN RADIUM AND URANIUM CORP. SITE MOUNT KISCO, WESTCHESTER COUNTY, NEW YORK

**EVENT DATES:** December 12 through 14, 2016

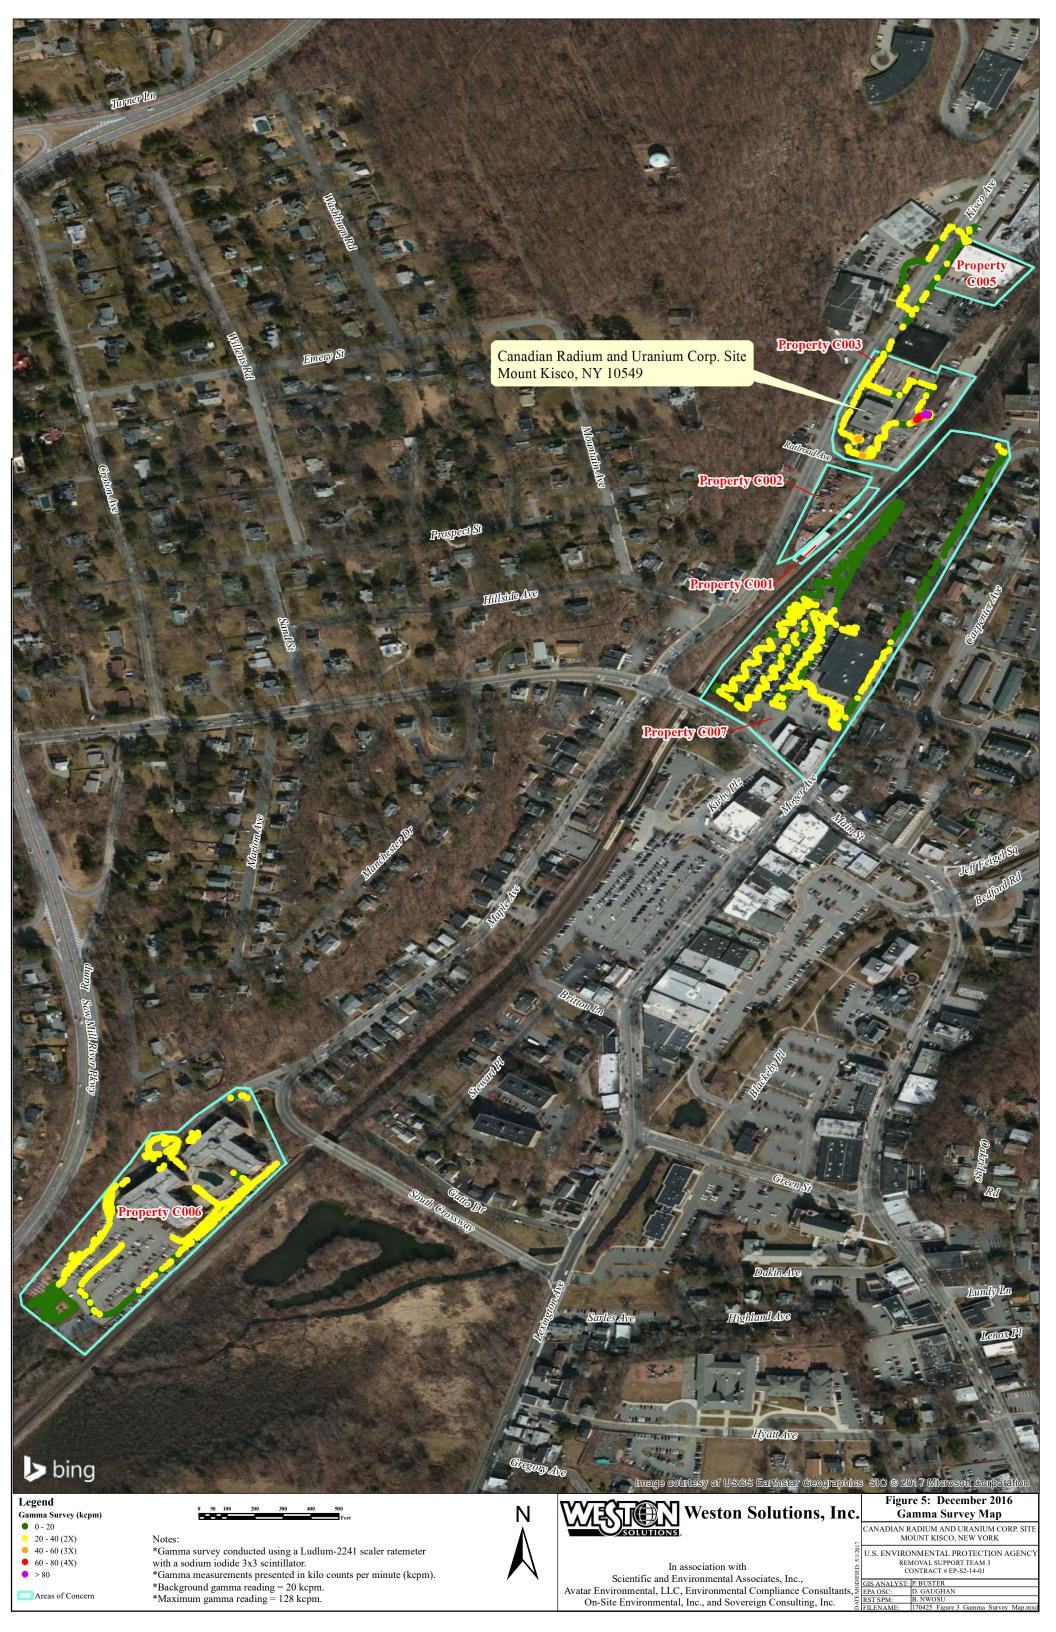
Figure 5: December 2016 Gamma Survey Map

A non-intrusive ground radiological survey was conducted at Properties P006 and P007 to verify if the aerial overflight information available to EPA was accurate. Background gamma readings ranged from 17 to 20 kilo counts per minute (kcpm). Based on the results of the ground radiological survey, gamma readings did not exceed 30 kcpm in both areas of interest, which is below 2x background. Refer to Attachment A, Figure 5: December 2016 Gamma Survey Map.

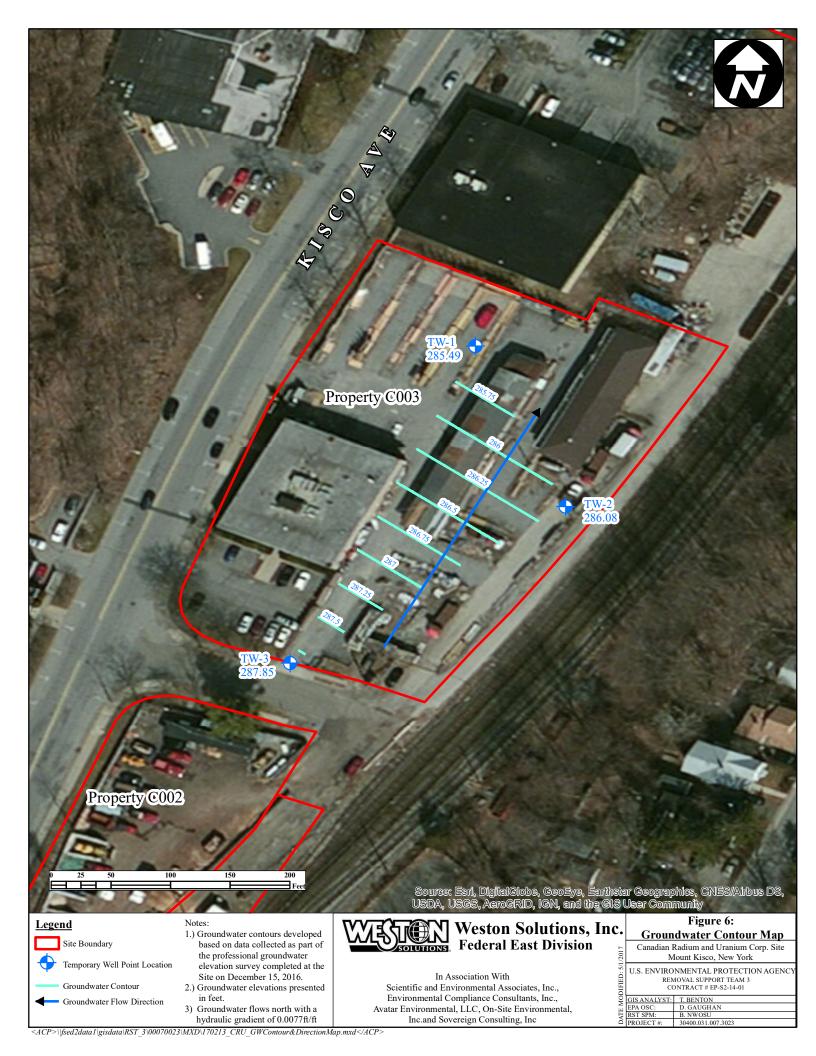
Figure 6: Groundwater Contour Map

Based on groundwater elevation information, groundwater flows north at the Site with a hydraulic gradient of 0.0077 feet per foot (ft/ft). Refer to Attachment A, Figure 6: Groundwater Contour Map.

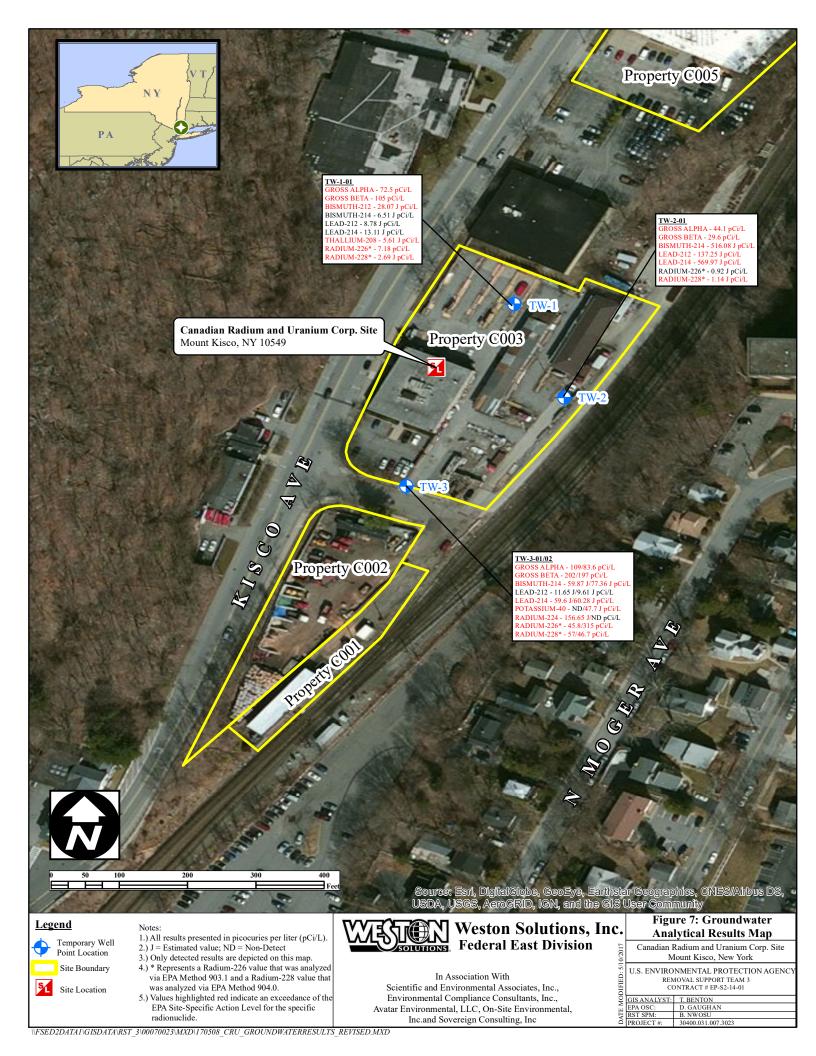
Figure 7: Groundwater Analytical Results Map

Based upon validated analytical results, the concentrations of gross alpha and gross beta particles exceeded the Site-Specific Action Levels of 15 pCi/L and 4 pCi/L, respectively, in all four groundwater samples, including the field duplicate. Exceedance of gross alpha particles ranged from 44.1 pCi/L in TW-2-01 to 109 pCi/L in TW-3-01, and exceedance of gross beta particles ranged from 29.6 pCi/L in TW-2-01 to 202 pCi/L in TW-3-01.

Based upon validated analytical results, the concentration of Ra-226 exceeded the Site-Specific Action Level of 5 pCi/L in two groundwater samples, (sample number and concentration in parenthesis) TW-1-01 (7.18 pCi/L) and TW-3-01 (45.8 pCi/L), and the field duplicate TW-3-02 (315 pCi/L) of TW-3-01.

Based upon validated analytical results, the concentration of Ra-228 exceeded the Site-Specific Action Level of 0.702 pCi/L in all four groundwater samples, including the field duplicate. Exceedance of Ra-228 ranged from 1.14 pCi/L in TW-2-01 to 46.7 pCi/L in TW-3-02 (duplicate of TW-3-01).

Refer to Attachment A, Figure 7: Groundwater Analytical Results Map, Attachment B, Table 1: Temporary Well Construction, Gauging, and Purging Information Summary Table, Table 2: Validated Groundwater Analytical Results Summary Table - Radioisotopes, and Attachment F: Data Validation Report.

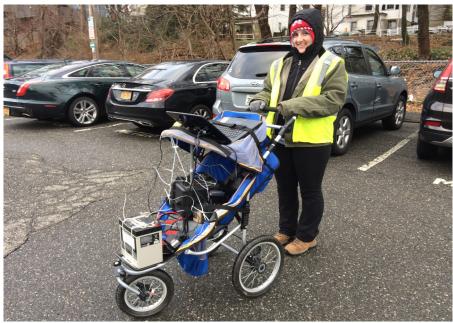
**Photograph 1:** Weston Solutions, Inc., Removal Support Team 3 (RST 3) personnel conducting gamma survey at the parking lot immediately adjacent to the Site on the eastern side of the railroad tracks and fronting on North Moger Avenue (Property C007) using a Ludlum-2241 Scaler Ratemeter with sodium iodide (NaI) 3x3 scintillator attachment. A baby buggy stroller was utilized to provide mobility

for the survey instrumentation setup.

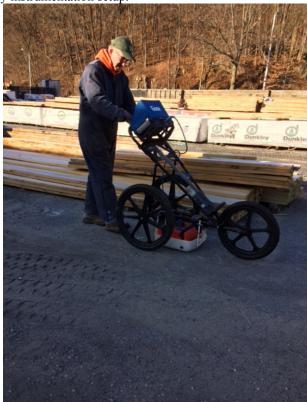
**Photograph 2:** Prior to conducting any drilling activities on-site, RST 3 drilling subcontractor, Environmental Field Services, Inc. (EFS), cleared each proposed temporary well point location for subsurface utilities using a ground penetrating radar (GPR).

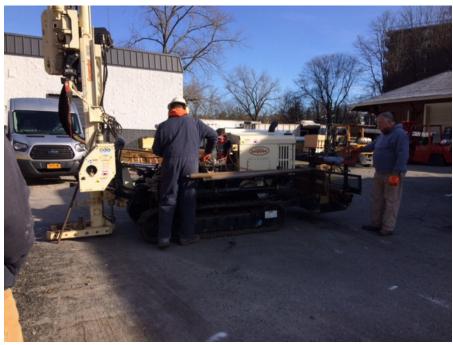
**Photograph 3:** EFS installed the temporary well points using a Geoprobe<sup>TM</sup> (Model 7822DT) to advance borings to the desired depths.

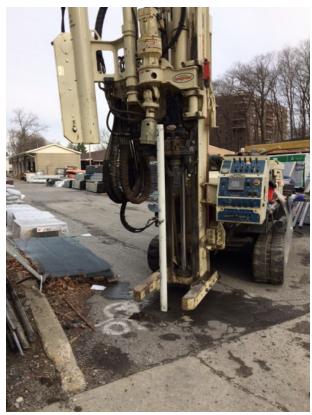
**Photograph 4:** The construction of each temporary well point consisted of a 10 foot 2-inch Schedule 40 polyvinyl chloride (PVC) screen (0.01 slot) plugged at the base with a PVC cap, and a 5 foot 2-inch Schedule 40 PVC casing with at least a 1 foot riser.

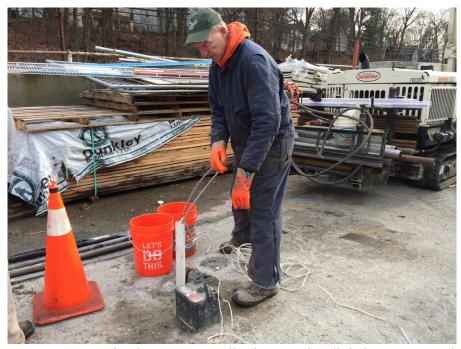
**Photograph 5:** After the temporary well points were installed, they were purged and surged with a Whale pump to facilitate influx of fresh groundwater from the aquifer, and then allowed to stabilize overnight.

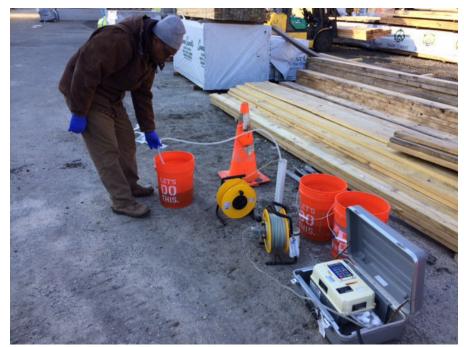
**Photograph 6:** A Solinst water level meter was utilized by RST 3 to record the water levels and total depths of the temporary well points prior to purging for sampling purposes. Utilizing a non-dedicated submersible Grundfos pump fitted with Teflon<sup>TM</sup> tubing, RST 3 purged at least three well volumes from each temporary well prior to sample collection.

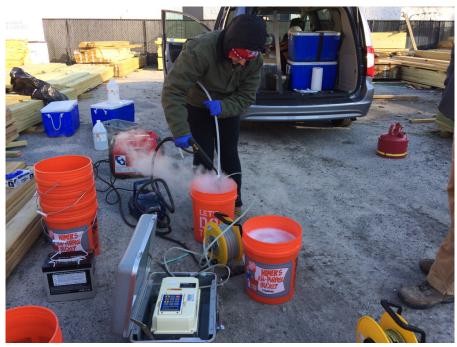
**Photograph 7:** Decontamination of the non-dedicated submersible pump was performed before and after sampling each temporary well point, and it involved scrubbing the pump exterior with an industrial soap (Alconox) and water, running the pump in a bucket of Alconox and water for 5 minutes, rinsing the pump exterior with tap water, running the pump in a bucket of tap water, steam cleaning the pump with deionized (DI) water, and air dry.

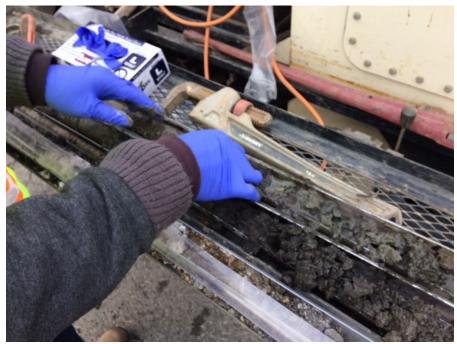
**Photograph 8:** RST 3 documented the physical characteristics and description of the soils extracted in each core from each boring location

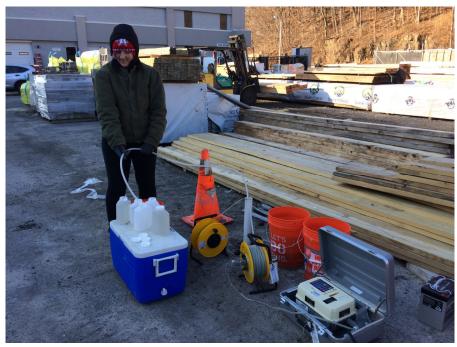
**Photograph 9:** RST 3 collected groundwater samples directly from the dedicated Teflon<sup>TM</sup> tubing utilized to purge each temporary well.

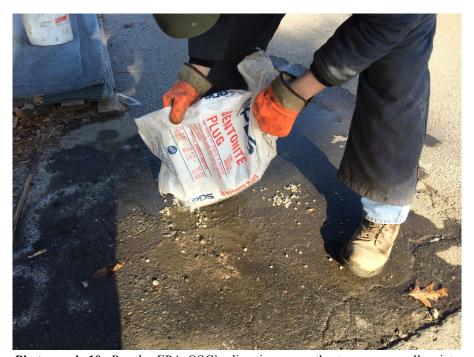
**Photograph 10:** Per the EPA OSC's directive, once the temporary well points were sampled, the investigation-derived waste (IDW), including well development purge water, sampling purge water, and decontamination fluid, were pumped back into each temporary well point. The boreholes were then backfilled in reverse order with the extracted soil in the cores, tamped down, and sealed with bentonite.
